BYD Battery-Box Premium HVS&HVM Service Guideline and Checklist for BCU-V2.0

Version 1.0

Valid for HVS 5.1 / 7.7 / 10.2 / 12.8 HVM 8.3 / 11.0 / 13.8 / 16.6 / 19.3 / 22.1

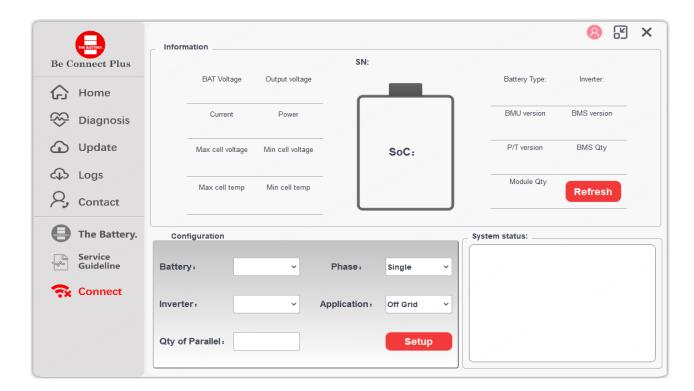
Note: You need a computer with Windows that will be connected to the battery Wi-Fi.

Log in as Installer to Be Connect Plus. The default password for the battery Wi-Fi is the same: BYDB-Box

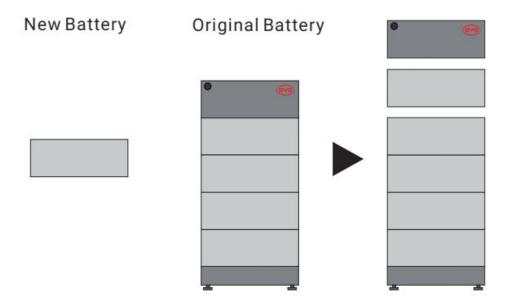
Please note: It is important that all modules of a battery tower have a similar state of charge (SOC) with a tolerance of 5%. New modules have about **30**% SOC. If the remaining modules have not yet been put into operation (not charged / discharged), the new module can be easily added. Otherwise, it is basically a module extension. In this case, please add the new module to the system only when the SOC of the system is between 25% and 35% (see extension process in the Operating Manual). Make sure to configure correctly after any change to the module quantity.
